# Imaging characteristics of incidentally detected cosmetic surgery-derived foreign bodies on CT images in the maxillofacial region

**Objectives** This study examined the imaging characteristics of cosmetic surgery-derived foreign bodies in the maxillofacial region through a retrospective review of cosmetic material foreign bodies incidentally detected on computed tomography (CT) images in routine clinical practice.

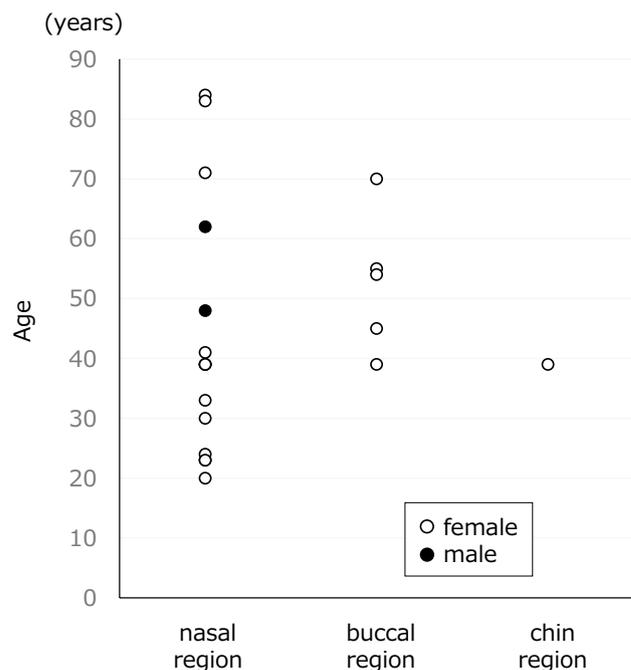
**Fig. 1** Patient ages and lesion locations: Cosmetic surgery-derived foreign bodies in the maxillofacial region were more common in women (90.5%, 19/21 cases), and the age range varied from 20 to 84 years. The two foreign bodies observed in the male were both in the nasal region

In total, there were 21 cases involving four types of cosmetic surgery-derived foreign bodies in the maxillofacial region identified via CT examination. There were 15 cases (one type) in the nasal region, five cases (two types) in the buccal region, and one case (one type) in the chin region. Their ages and sexes are shown in Fig. 1.

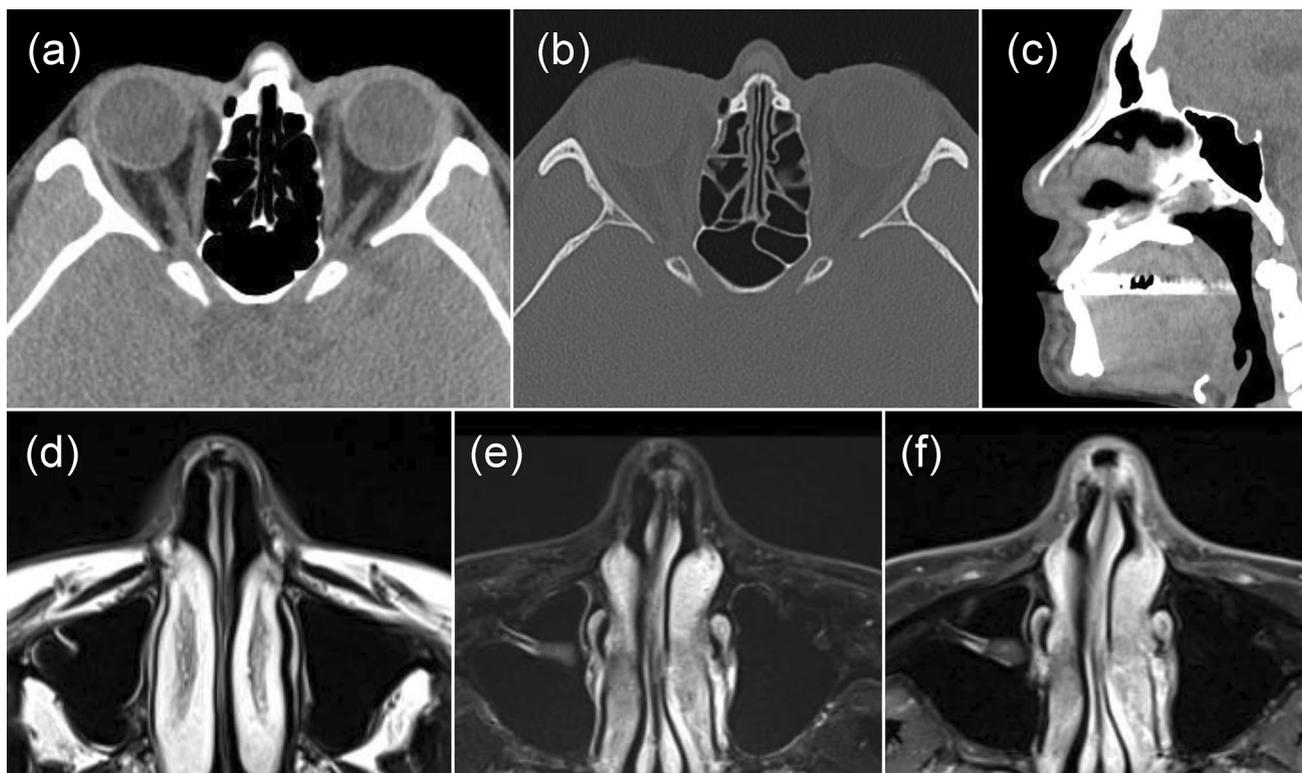
**Fig. 2** Foreign body in the nasal region. A foreign body comprising a suspected nasal prosthesis was observed on the nasal dorsum. The foreign material showed an I-shaped high-density area with a CT value of 218 HU (a: axial soft tissue condition, b: axial bone condi-

tion, c: sagittal soft tissue condition). It showed no signal intensity on T1-weighted (d) and STIR (e) images, and no contrast enhancement on contrast-enhanced T1-weighted images (f)

All the 15 cases in the nasal region were located on the nasal dorsum. In terms of shape, 13 cases had a straight I-shape and two cases had an L-shape; thus, the 15 cases had a rod-like morphology Fig. 2. The mean CT value of the 14 cases was 278.0 Hounsfield units (HU; range: 4–540 HU) Fig. 3. One male case was plate like and CT values could not be determined, but the density was uniform on soft tissue images. Hard tissue images showed homogeneous density in 12 cases, but three cases displayed homogeneous density surrounded by an osteosclerotic margin. Regarding other modalities, panoramic radiographs showed no obvious findings, although increased opacity in the median nasal area was suspected in some cases. Six cases had relevant findings on MRI. In five cases, nasal foreign bodies showed signal voids on T1-weighted and STIR images, similar to

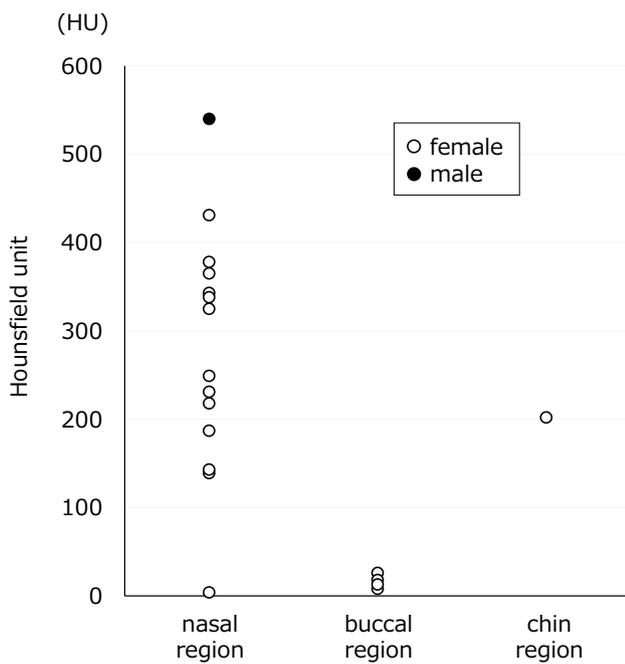
**Fig. 3** Computed tomography values (in Hounsfield units) of lesions: Cosmetic surgery-derived foreign bodies in the nasal region were observed over a wide range of 4–540 HU, suggesting that various materials were used. On the contrary, the buccal foreign bodies showed a value of 8–26 HU, which is similar to that of water, and an injection agent made of a material similar to water was suspected

In the buccal region, five foreign bodies (two types) were detected. In one case, multiple metallic thread-like linear foreign bodies were present under the buccal skin (Fig. 4). These foreign bodies were linear and CT values could not be obtained. Concerning other modalities, panoramic radiographs showed numerous thread-like opacities overlapping from the maxillary sinus to the maxilla and throughout the mandible, but not in the orbit or pyriform aperture. In four cases, the lesions comprised irregularly shaped lumps or cords extending from the zygomaticus muscle to the subcutaneous fat layer; they were quite visible (Fig. 5). The mean CT value of these four buccal foreign bodies was 16.3 HU (range: 8–26 HU) (Fig. 3). With respect to other modalities, panoramic radiographs showed no obvious findings. MRI

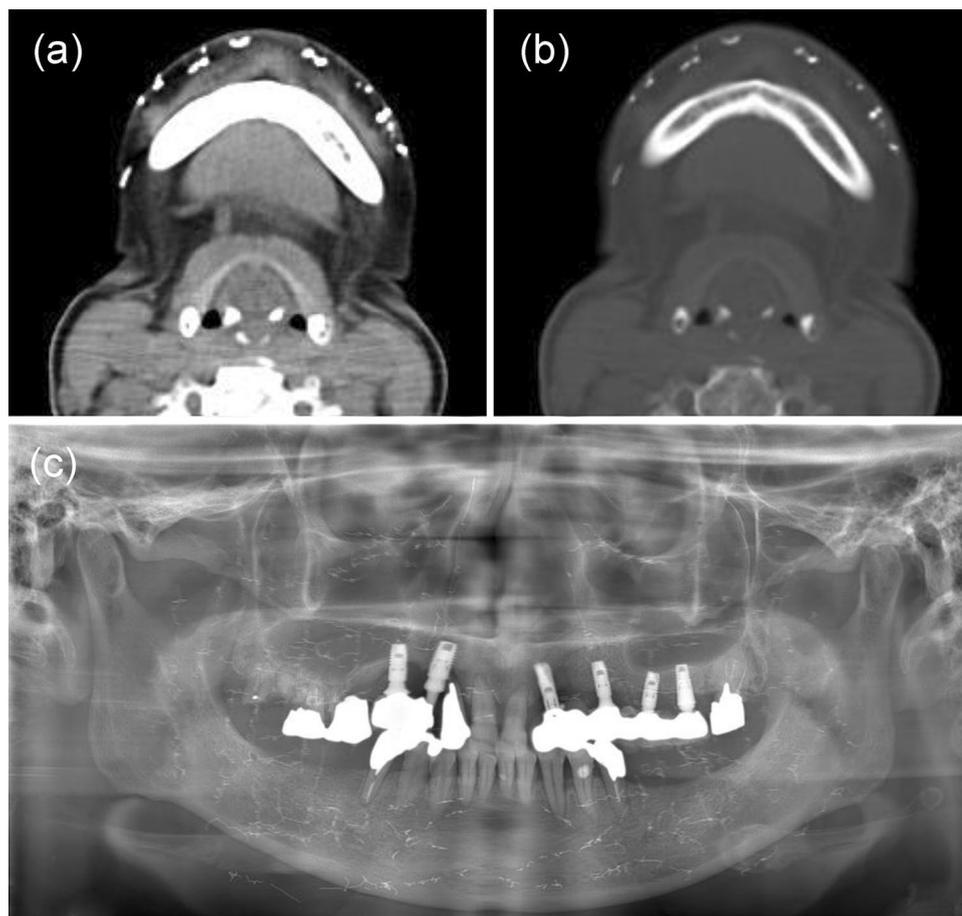
**Fig. 4** Foreign body in the buccal region. Multiple metallic thread-like linear foreign bodies were detected under the buccal skin (**a**: axial soft tissue condition, **b**: axial bone condition). Panoramic radiographs showed numerous thread-like opacities overlapping from the maxillary sinus to the maxilla and throughout the mandible, but not in the orbit or pyriform aperture (**c**)

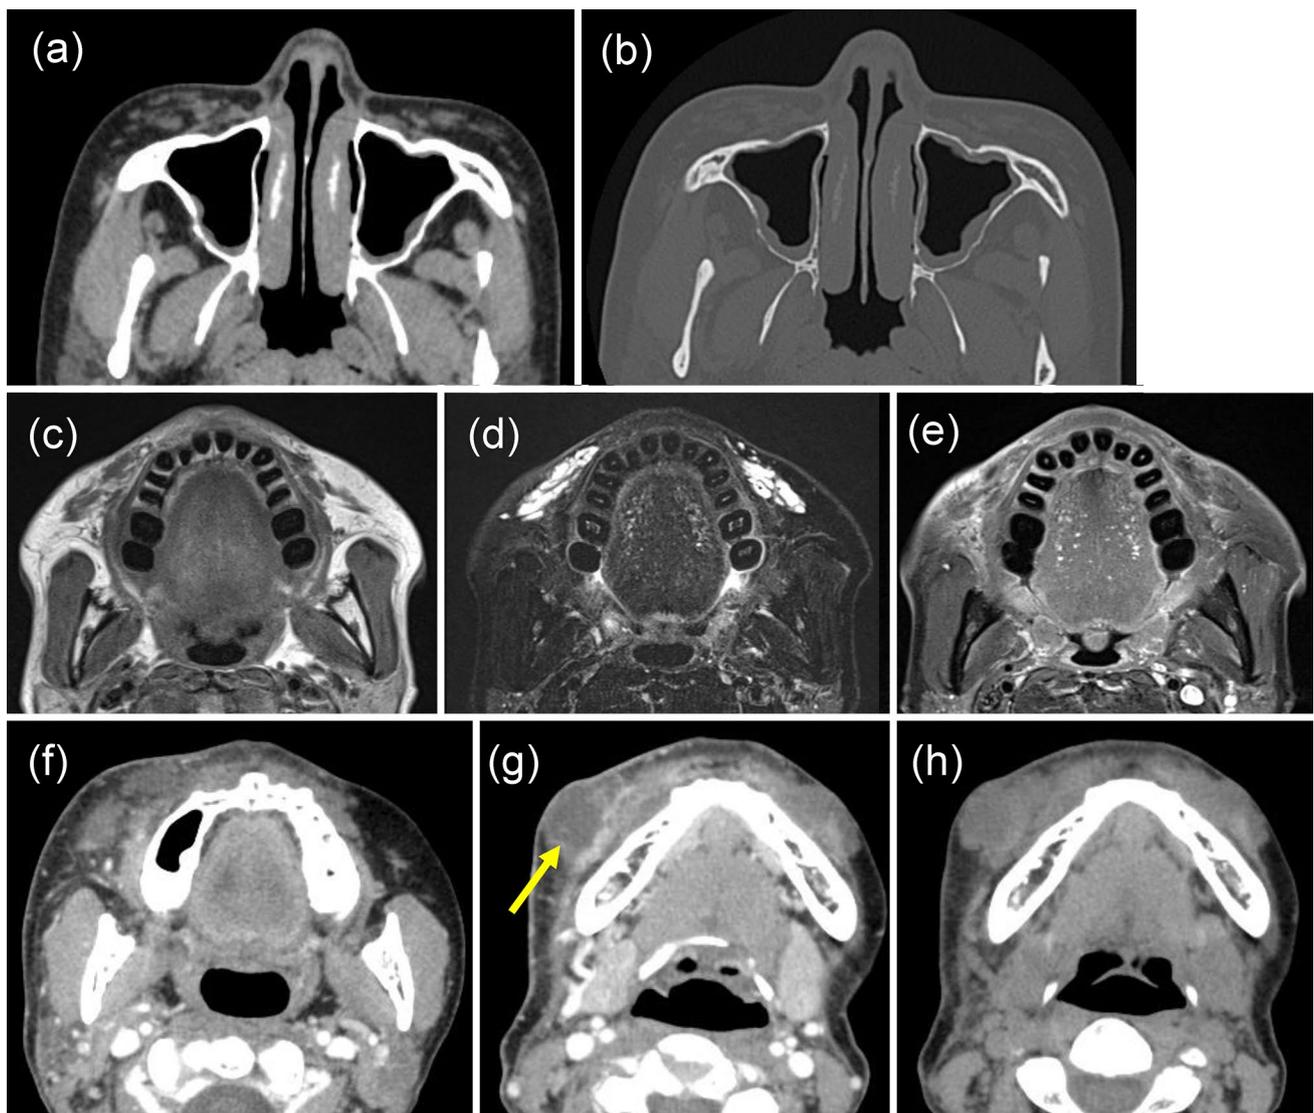
**Fig. 5** Foreign body in the buccal region. Injectable fillers comprising multiple irregularly shaped, cord-like injections were present in the bilateral buccal region. CT soft tissue images (a) were readable, but the bone condition was poorly delineated (b). T1-weighted images (c) showed moderate signal intensity and STIR images (d) showed high signal intensity; contrast T1-weighted images (e) showed no contrast enhancement. A 54-year-old woman with a his-

tory of Aquamid® (f, g); right-sided buccal swelling was evident, with a large mass (f). In another image, an abscess (arrow) without internal contrast was observed (g). A foreign body was also observed in the fat layer within the left buccal region, and the presence of a high-density cosmetic surgery-derived foreign body was suspected (h)

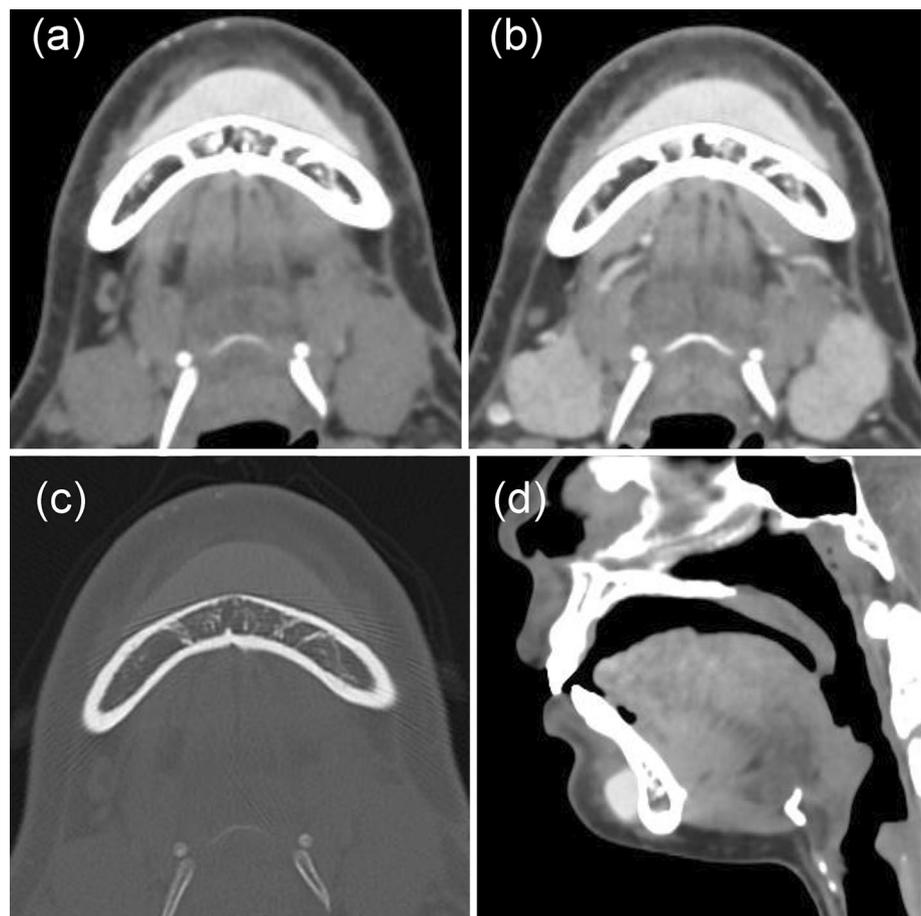
**Fig. 6** Foreign body in the chin region. A foreign body (presumably a silicone jaw implant) was identified in the chin region. On CT soft tissue images, the foreign body showed a uniform high-density area of 202 HU (a) and no contrast enhancement (b). In terms of bone condition, the morphology of the foreign body was visible, but its density was low and delineation was poor (c). Sagittal images showed a clear, well-defined jaw formation (d)

The foreign body in the chin region showed a hemispherical morphology with smooth edges. The foreign body exhibited a uniform high-density area of 202 HU without contrast enhancement (Fig. 6). Regarding other modalities, panoramic radiographs showed no abnormal findings in the chin region. In the case involving the chin region, no cosmetic surgery was declared prior to examination; the detection of foreign bodies was incidental and unrelated to the disease targeted by the CT scan.
